Mary River Turtle Protection: Tiaro District of Southeast Queensland, 2005 - 2006 nesting season

Conservation technical and data report
Volume 2006. Number 8
ISSN 1449-194X

Mary River Turtle Protection: Tiaro District of Southeast Queensland, 2005 - 2006 nesting season
ISSN 1449-194X

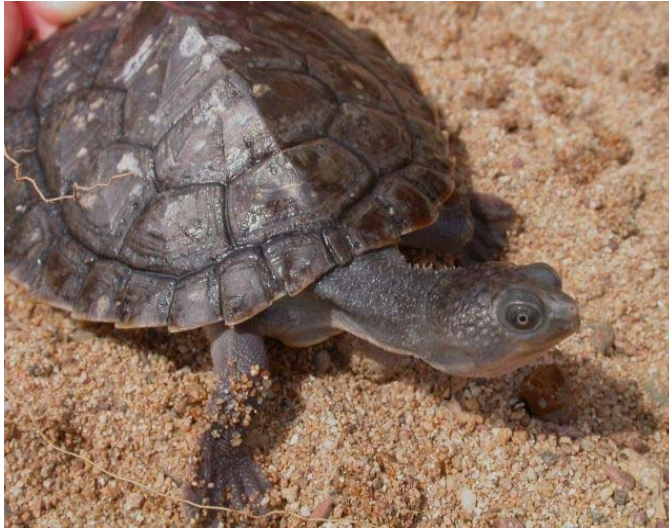
Figure 1. Mary River Turtle hatchling, *Elusor macrurus*.

Tiaro & District Landcare Group continues to be concerned about the survival of *Elusor macrurus* (Mary River turtle) (Figure 1). It is listed as endangered under federal legislation, Environment Protection and Biodiversity Conservation Act 1999 (Department of Environment and Heritage 2007) and under the Queensland Nature Conservation (Wildlife) Regulation 1994 Schedule 2 (Queensland Government 2005). Previous studies indicate that the breeding success of the species may be dramatically reduced due to nest predation and a decrease in numbers of breeding turtles. The work described here builds upon previous research (Flakus 2002), and knowledge and skills gained during conservation work undertaken each nesting season since October 2001 (Parkes *et al* 2002). As in previous years, nest protection was concentrated on most productive known nesting banks in the Tiaro reaches of the Mary River.

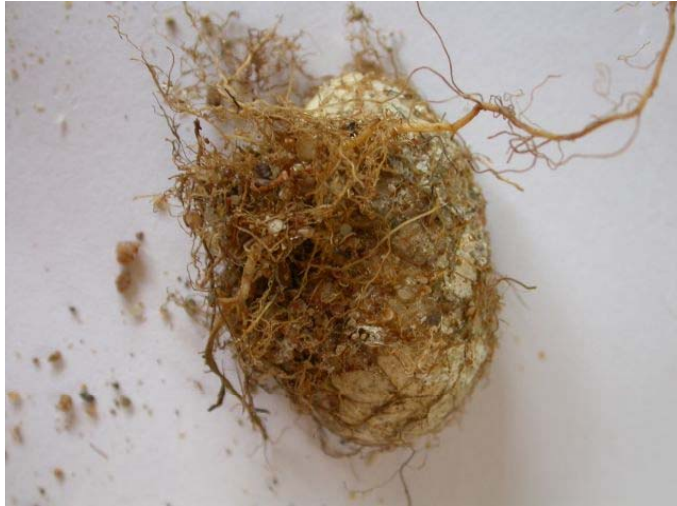
Figure 2. Root bound egg.

At nesting site 2, the impact of the floodwaters on the nests is unknown. Eggs could not be found in four nests. Twenty-six undeveloped eggs from four nests were root bound from nearby grasses (Figure 2). A total of 151 empty shells were found in 14 nests (Table 2).

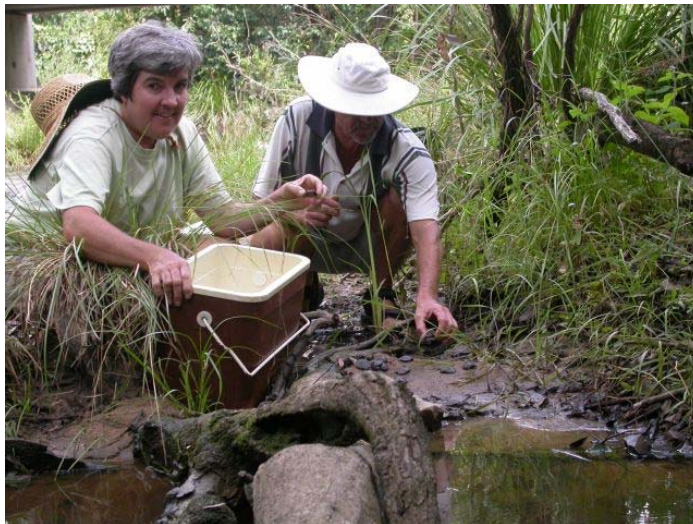
Figure 3. Releasing artificially incubated hatchlings.

empty shells inside the nest and 148 hatchlings were successfully incubated and released (73% success) (Table 3 and Figure 3). However, this percentage is a percentage of eggs found and does not include the 10 nests for which there is no data (Table 3). If it is assumed that each of those nests contained 15 eggs, then the hatching success for the season would be 53%. It is not known how many hatchlings successfully reached the protection of the water.

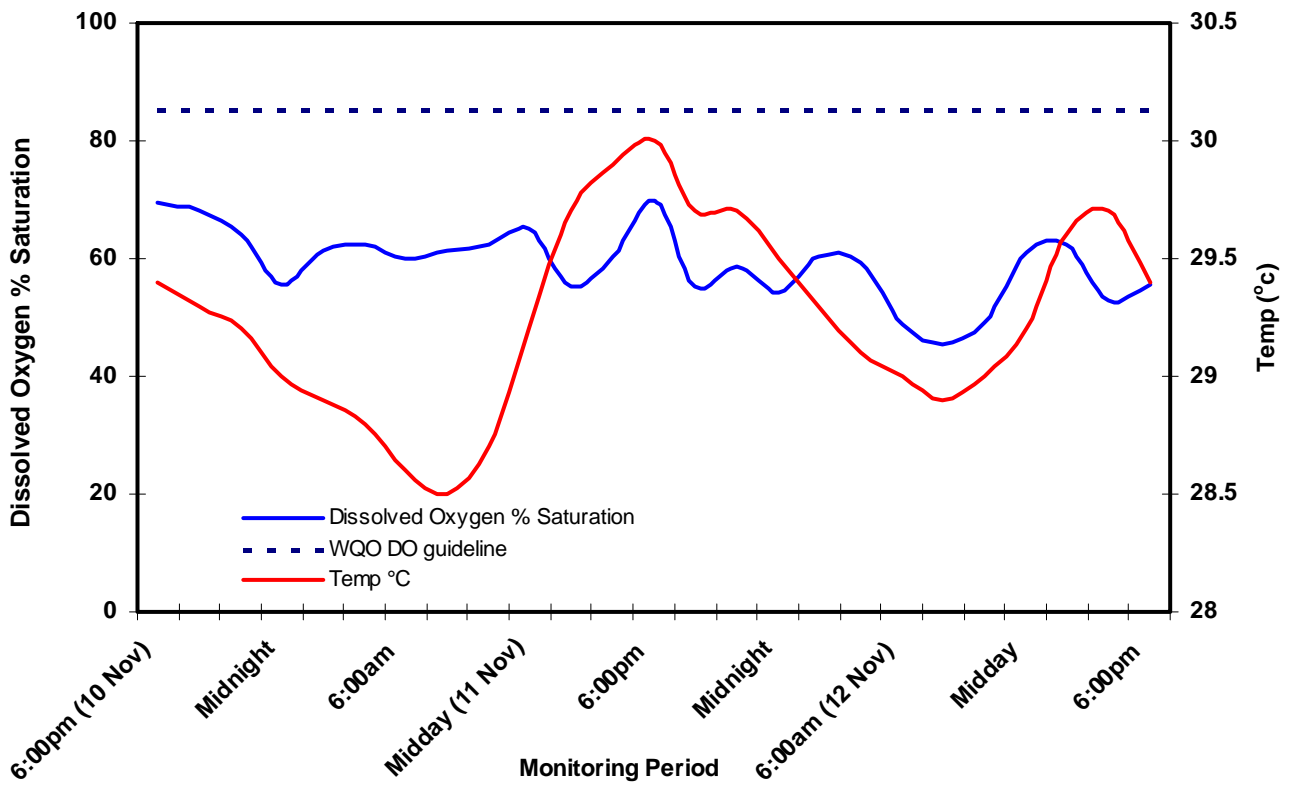
Figure 4. Dissolved Oxygen data from the Mary River at water sample site A, 10 -12 November 2005

The Dissolved Oxygen (DO) level of the Mary River at this site between 10 and 12 November 2005 did not meet the EPA Water Quality Guidelines for the Mary River¹. These guidelines state a range of 85% - 110% is acceptable (Environmental Protection Agency 2006). The DO level fluctuated between 45.4% at 7am and 69.8% at 5pm (Figure 4). This is expected as the lowest dissolved oxygen is usually early in the morning, as photosynthesis ceases at night. The highest dissolved oxygen level is expected during the afternoon as sunlight is at its highest intensity, hence stimulating greatest quantity of photosynthesis.

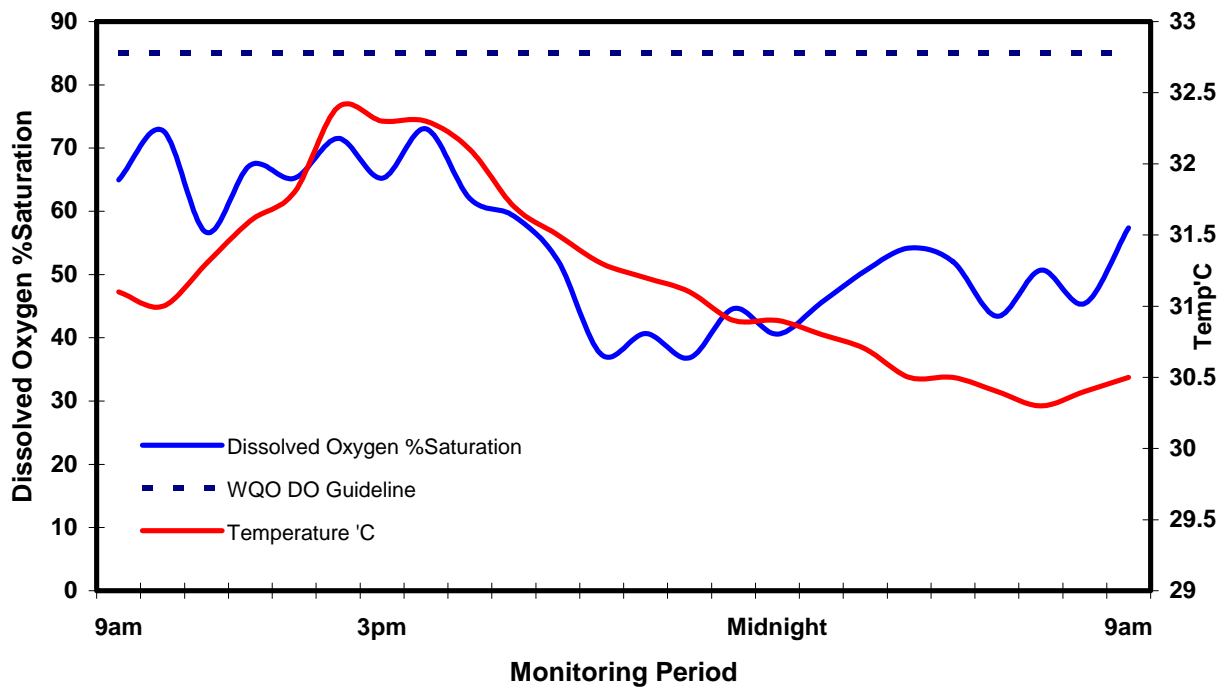
Figure 5. Dissolved Oxygen data from the Mary River water sample site A, 20 February 2006.

The temperature during this period varied little, with the lowest temperature of 28.9°C recorded at 7am, and the highest temperature of 30°C recorded at 5pm (Figure 5). These temperatures are quite high for water temperatures but are consistent with other measurements taken on the Mary River during summer.

DO samples taken in February 2006 at this site did not meet the EPA water quality guidelines¹. The dissolved oxygen logging during a 24 hour period in summer shows levels well below guideline values of 85% DO saturation (Figure 5). The figures show a similar trend to the data collected in November 2005 at the same site (Figure 4 and Figure 5), where the peak of dissolved oxygen is reached during the middle of the afternoon. The peak was still below the recommended guideline value of 85% for the Mary River. This represents a direct relationship with increased temperature of the water column.

Temperatures recorded in the February 2006 sample were higher than those recorded in November 2005 at the same site. Temperatures upwards of 32°C were recorded in the shaded area where the logger was deployed. This is consistent with other samples taken on the Mary River during that period. Late January 2006 was exceptionally hot, which is reflected in the water temperatures. Hot water temperatures in early February 2006 are suspected of a major fish-kill in the Mary River near Kenilworth.

The February 2006 sample was limited to only 24 hours due to water rats (*Hydromys chrysogaster*) dislodging the sensor from the unit's handset. The equipment was deployed for five days, but only recorded the first day of results.

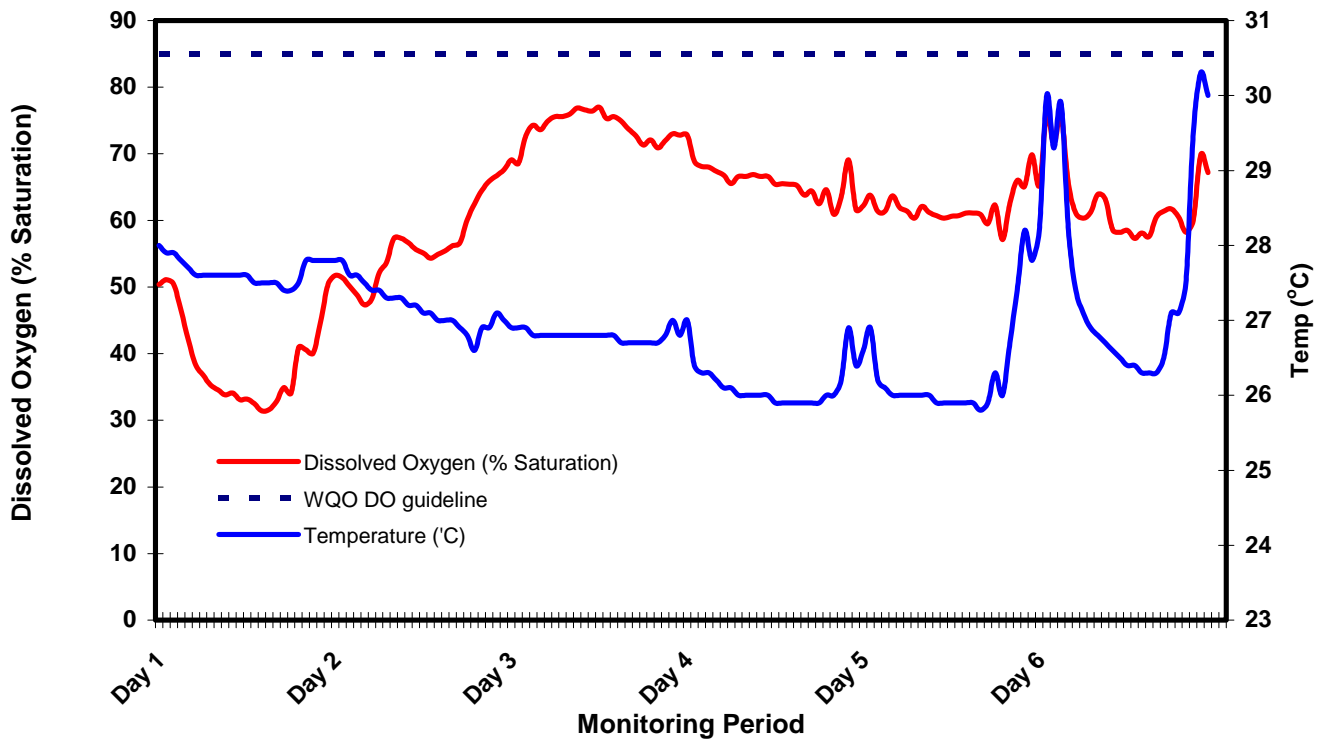
Figure 6. Dissolved Oxygen data from water sample site B on the Mary River 3-9 March 2006

The DO level recorded from 3–9 March 2006 at this site did not comply with the EPA water quality guidelines for DO¹. During the first day of sampling the lowest dissolved oxygen level was recorded of 31.4% saturation at 5am on 4 March 2006. The DO level steadily increased and remained consistent around 60-70% saturation (Figure 6). Most logically this was due to a small flow event experienced in the Mary River during the sampling. The flow event has had the effect of 'smoothing' out the results – particularly from day 2 to day 4 – when the flow peak occurred. This small flow event could have increased the dissolved oxygen level to above that normally experienced under baseflow conditions.

These figures are still below 85% saturation recommended by EPA for the Mary River.

Temperature remained reasonably static from day 1 until day 6 at around 26°C. This can be attributed to the flow event experienced during the sampling. Temperature levels then spiked on day 6 at 30 degrees at 5pm in the afternoon of 8 March 2006 once baseflow conditions were returned. The weather conditions on the day the equipment was deployed were overcast with some rain recorded upstream on the Mary River.

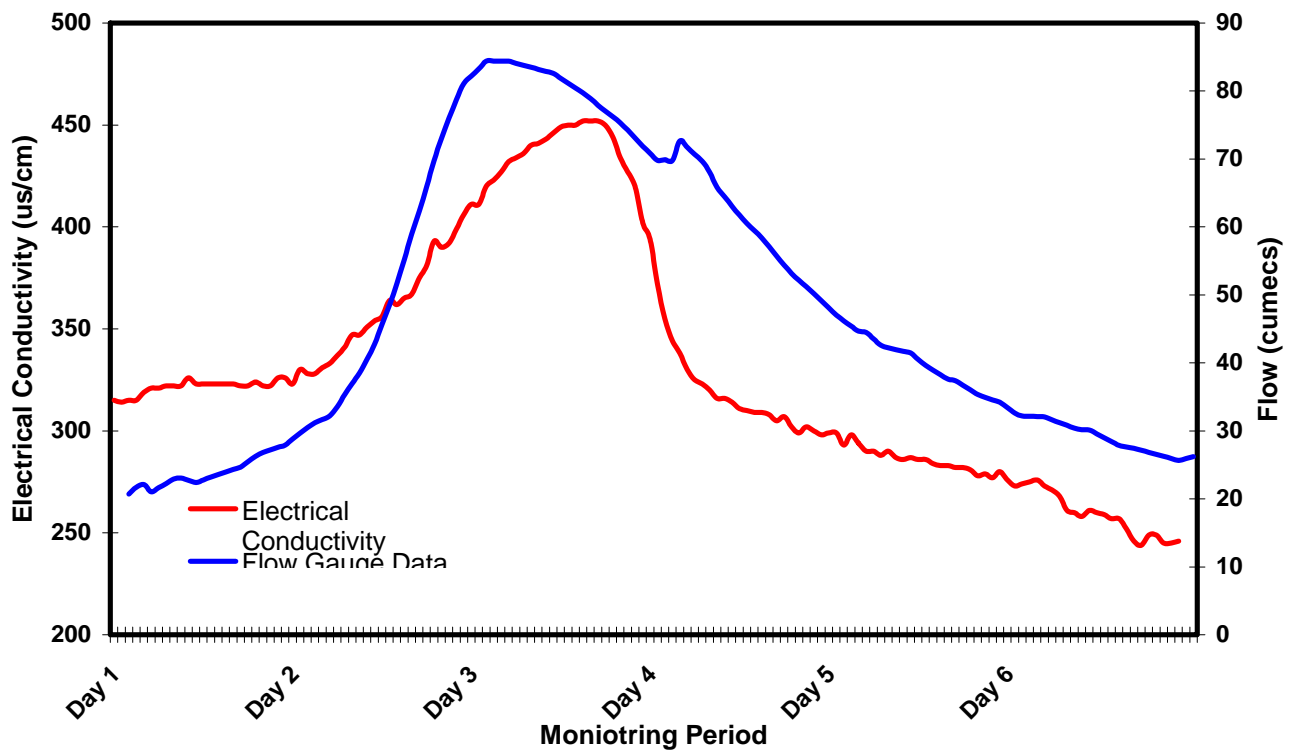
Figure 7. Electrical conductivity and flow data recorded from water sample site B on the Mary River 3-9 March 2006.

During the sampling of water sample site B a small flow event was experienced at the site. Rain from upstream in the catchment had caused the river to rise. River flow information was obtained which illustrates on day 1 flow was at normal levels – approximately 20 cumecs. On day 3 the flow peaked at approximately 85 cumecs, and then tapered back to approximately 20 cumecs (Figure 7). During this flow event the salinity level (electrical conductivity) also had a corresponding increase proportional to the quantity of flow.

Days prior to the sampling at this site, rain was received in the Munna, Wide Bay and Gutchy Creek sub-catchments – all upstream of the sampling site. These sub-catchments all experience higher surface water salinity levels than the Mary River, and probably explain why salinity levels increased proportionally to river flow levels. Generally rainfall causes dilution of the salt levels in the river water during flow events.
